Navajo Abandoned Uranium Mine

Site Screen Report

Enos Johnson Claim? AUM Site

March 2010

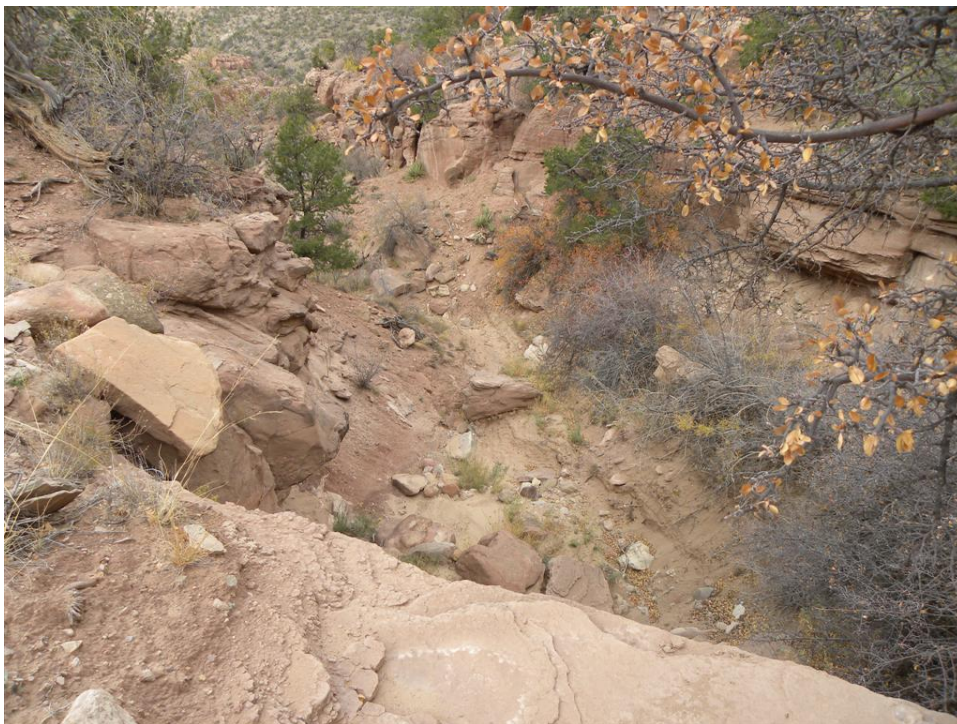
Photo 6. Drainage

A total of 1,411 gamma radiation measurements were collected from the mine site, ranging from 9,903 cpm to 189,043 cpm. Measurements in the vicinity of the waste debris were found at levels of approximately 180,000 cpm, and in the upper drainage ranging from 60,000 to 80,000 cpm. The measurements are represented in Figures 1 and 2.
